Supervision and Environmental Monitoring of River Training and Dredging Works on Critical Sectors on the Danube River

STAKEHOLDER'S FORUM MEETING No.4 – 9. November 2018

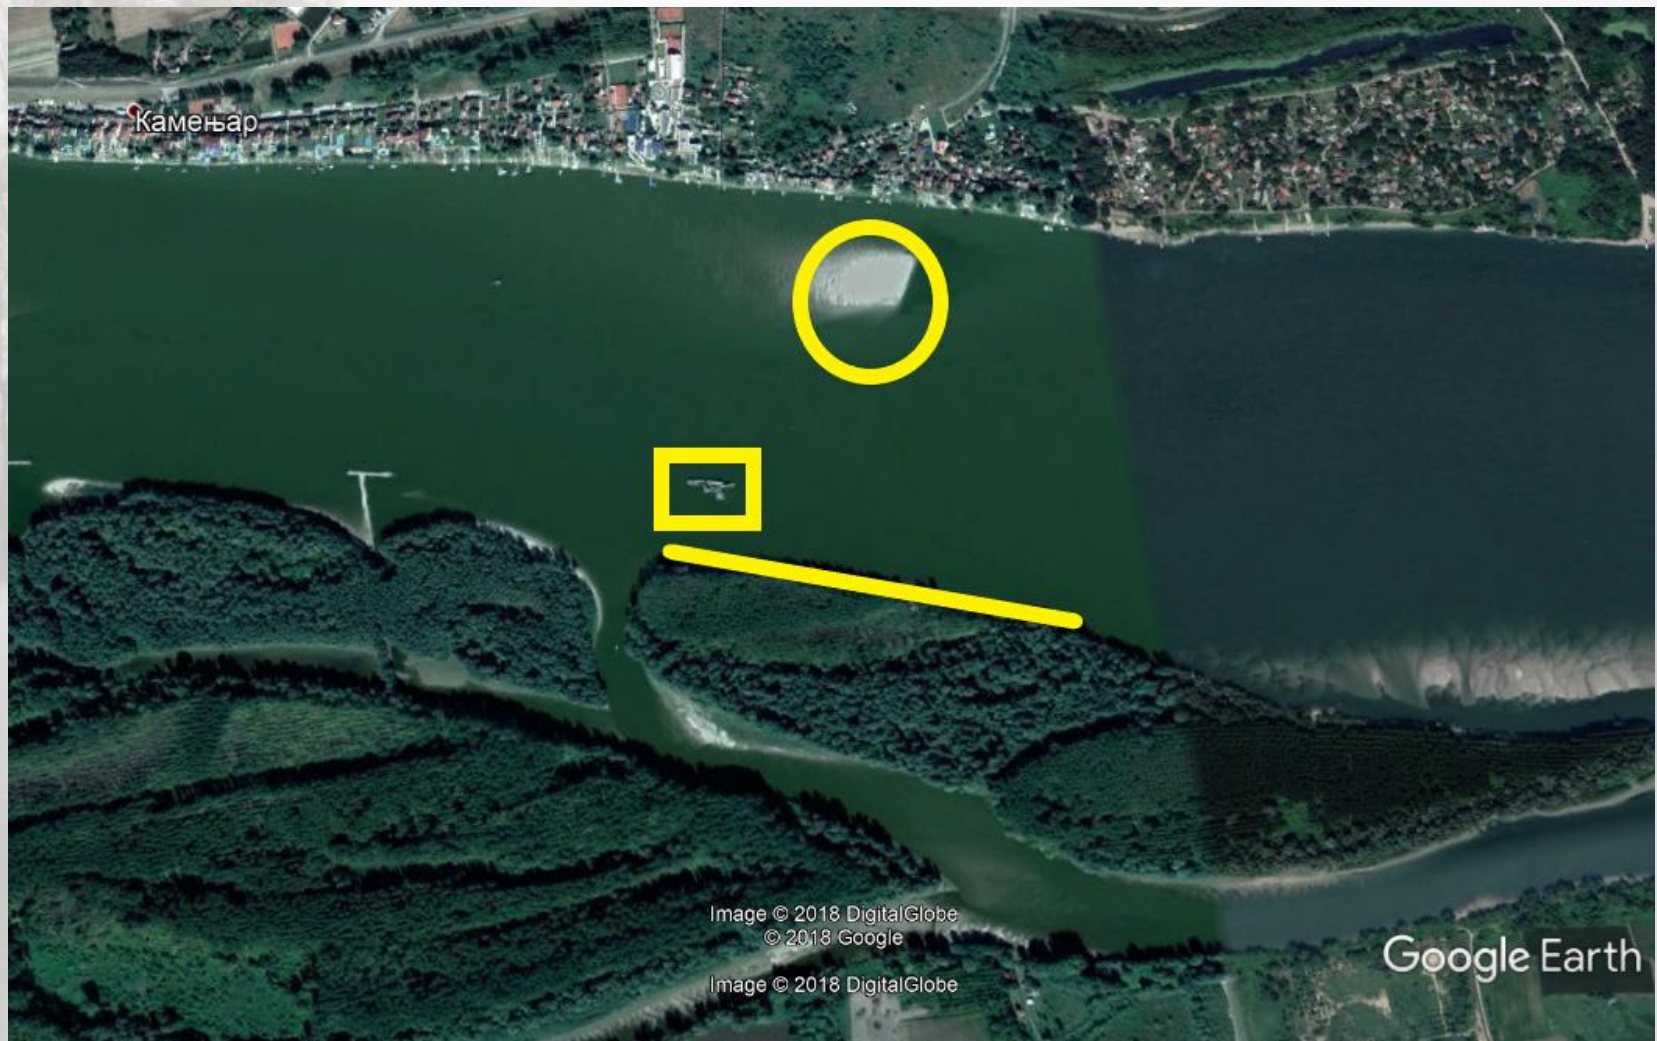
Monitoring area on the right river bank, location of the work mechanization and location of the birds populations on the sandy island

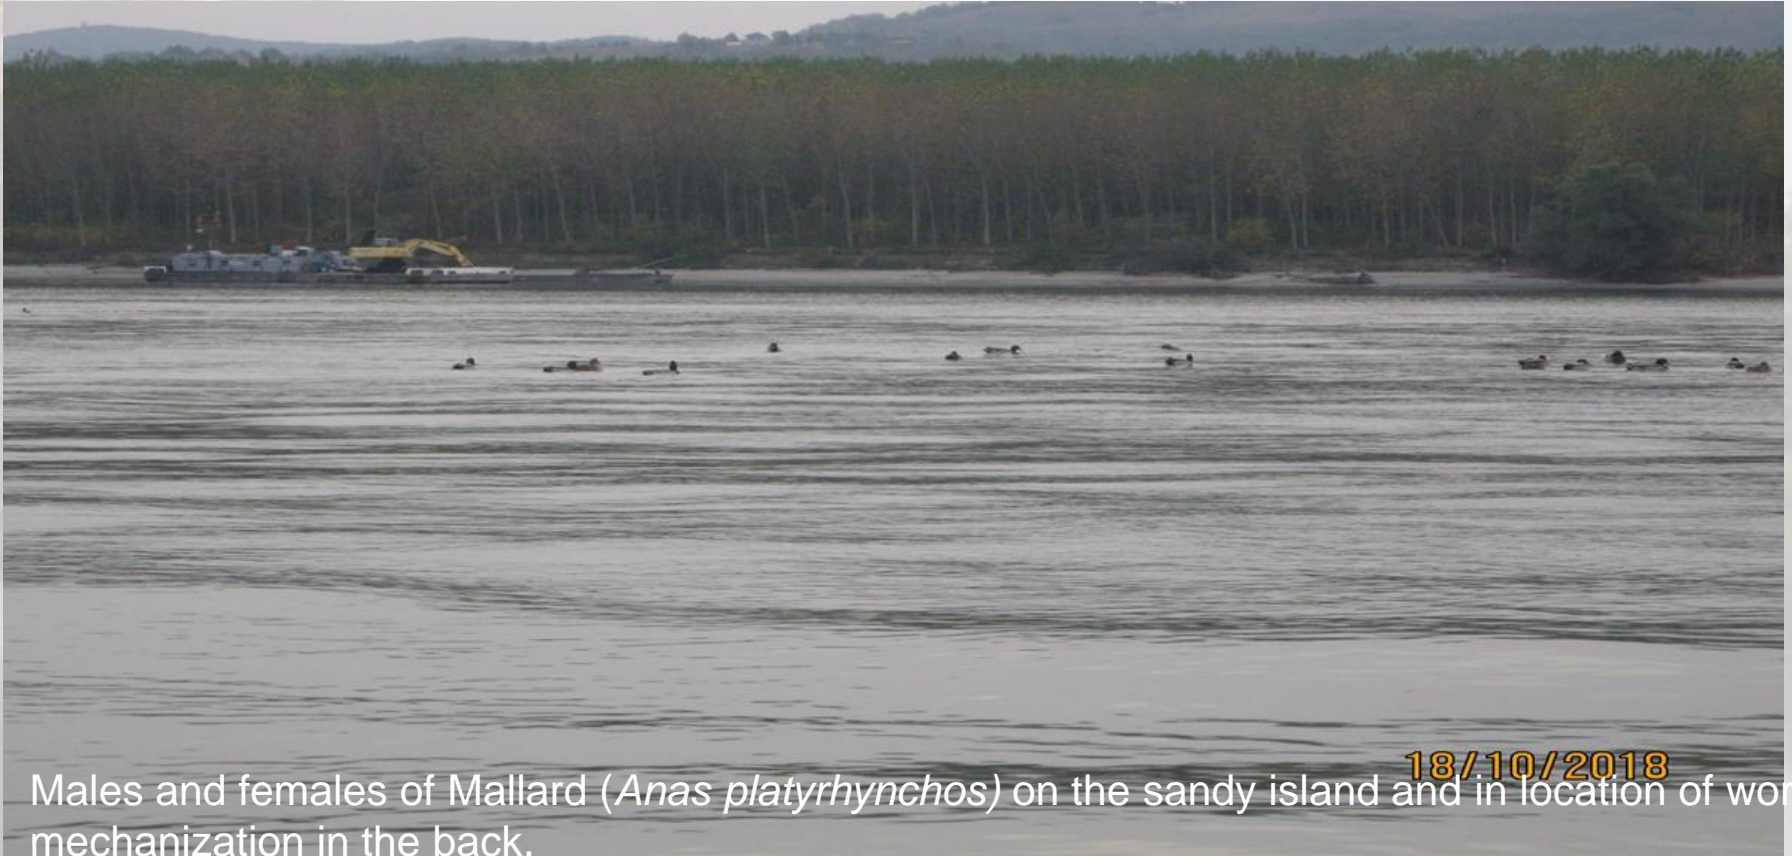
(Great Cormorant *Phalacrocorax carbo*) is presented by few individuals and does not make colony there.

All birds are not related to the right bank and do not make nests there.

Average distance from work mechanization to the birds populations is about 300 m.

According to that, it can be concluded that works do not impact on water birds populations, neither on behaviour and nesting.

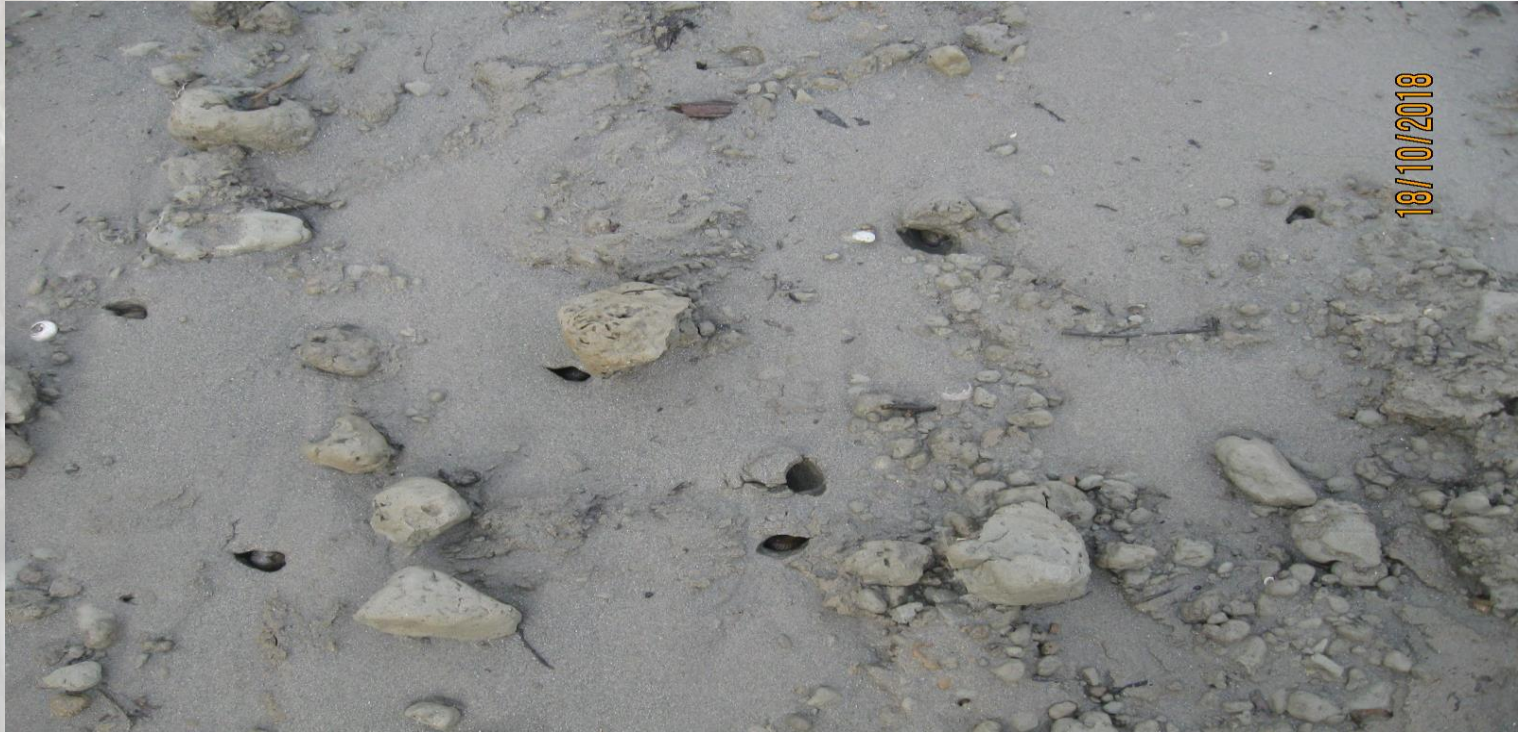
Individuals of *Corbicula* genus buried deeper in the sand in the seeking for humidity they remained on the sandy bank after lowering of water level

Populations are mostly represented by *Corbicula* genus (over 90% of all present individuals), which are presented in several dozen of individuals in the sand in work zone, and probably up to several hundreds in the zone of 2-3 m of water depth.

Population of mussels on the right bank live in shallow sand and are affected only by low water level.

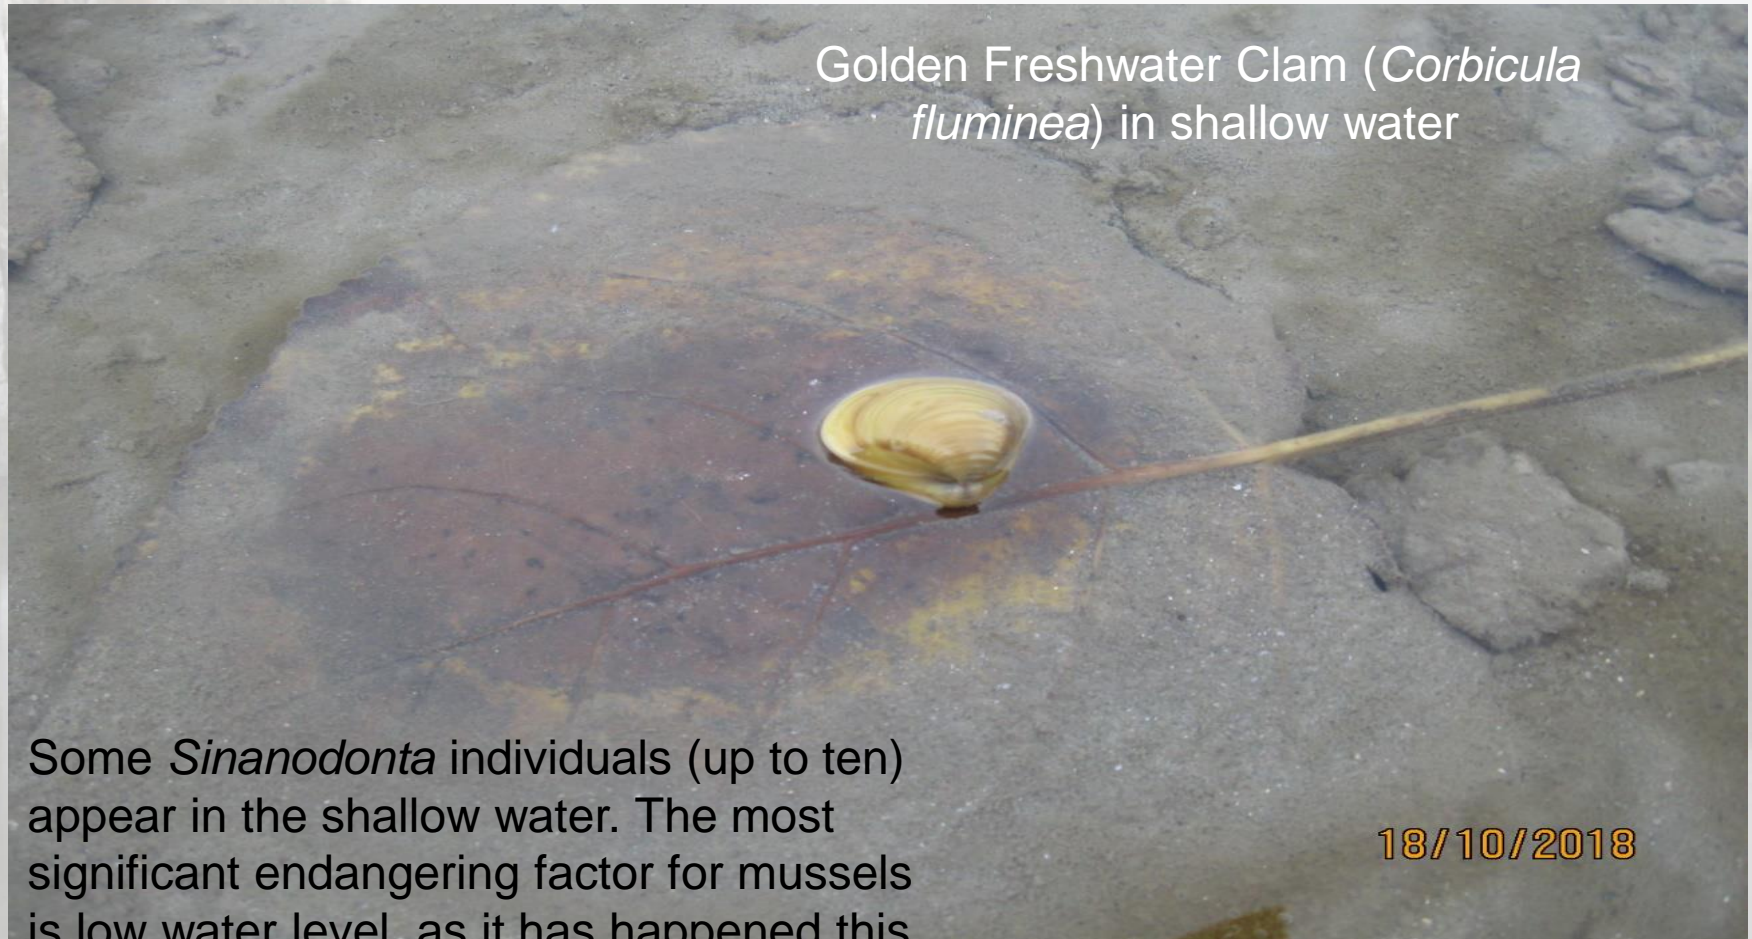
Golden Freshwater Clam (*Corbicula fluminea*) in shallow water

Some *Sinanodonta* individuals (up to ten) appear in the shallow water. The most significant endangering factor for mussels is low water level, as it has happened this summer and autumn due to their low speed of movements (20-30 cm/h) and consequently, inability of finding favourable habitat quickly (i.e. water sediment)

Vital individuals of mussels are recorded in the shallow water (in seeking for humidity), but also in sand, which remained out of water due to the water lowering.
