INTERMEDIATE ENVIRONMENTAL MONITORING REPORT AFTER WORKS n° 1

ČORTANOVCI – SUMMARY OF RESULTS

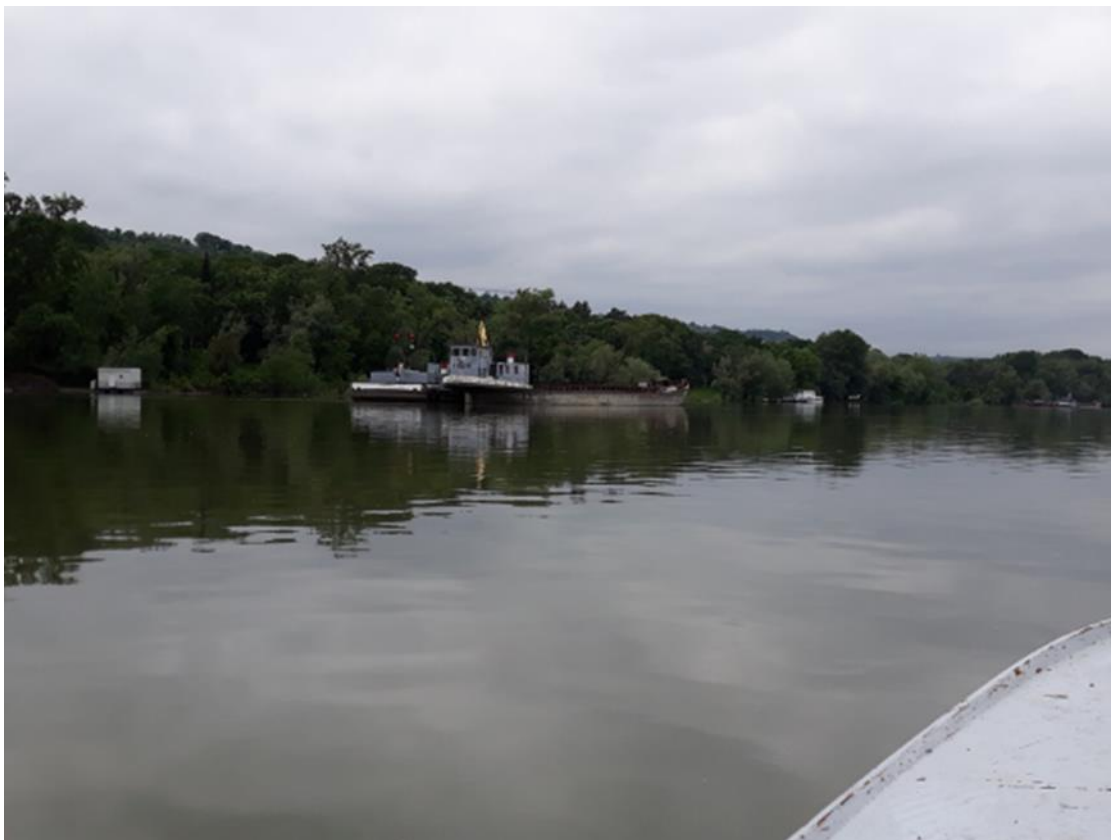
Figure 1 Čortanovci critical sector

Construction works have been performed on two locations Sill 22.2 and sill 22.1.

Construction works were started at the downstream location (sill 22-2), and just after approximately three weeks (May 15th they were started at the upstream location, sill 22.1).

Floating barge with construction material was used as a temporary storage for solid material like steel armature (reinforcement bar) and new rolls of geotextile are into the foil Floating office.

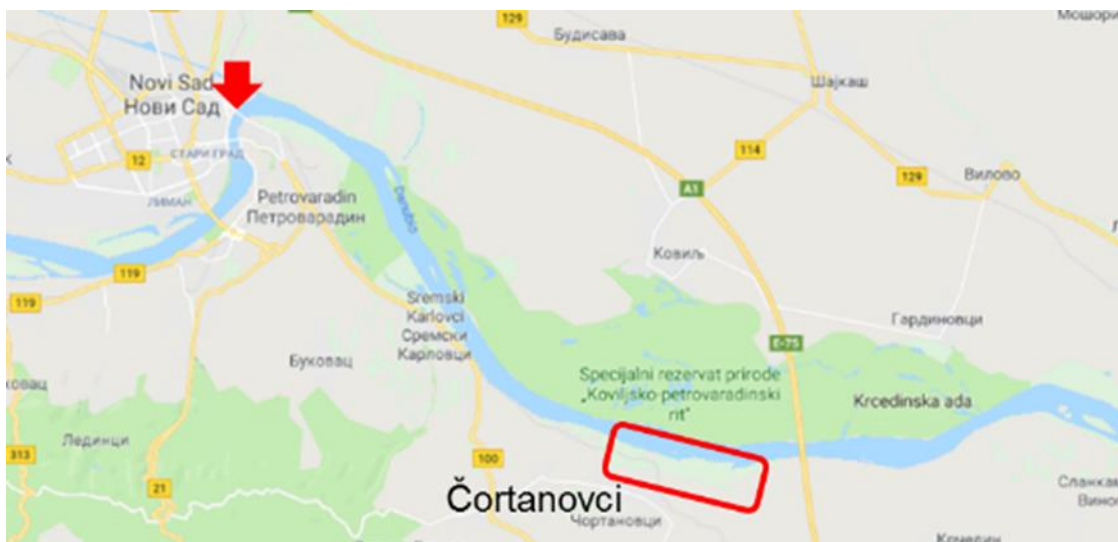
River stretch Čortanovci is located downstream from gauging station Novi Sad.

Downstream of Vojvodina capital – Novi Sad between km1241+600 and km1235 has been situated stretch Čortanovci. It is characterized by a typical hourglass shape, with approximately 350m width at the narrowest section. Riverbed are tapering from the width of 600 m to 350 m in contraction and spreading on 840 m downstream. Such morphological characteristics are favorable for bed load deposition downstream of contraction where water current slowing down and provides conditions for sedimentation. Water flow is divided into two currents, where one of the branches is dominant and attracts more water flow.
