INTERMEDIATE ENVIRONMENTAL MONITORING REPORT DURING WORKS n° 1

ČORTANOVCI – SUMMARY OF RESULTS

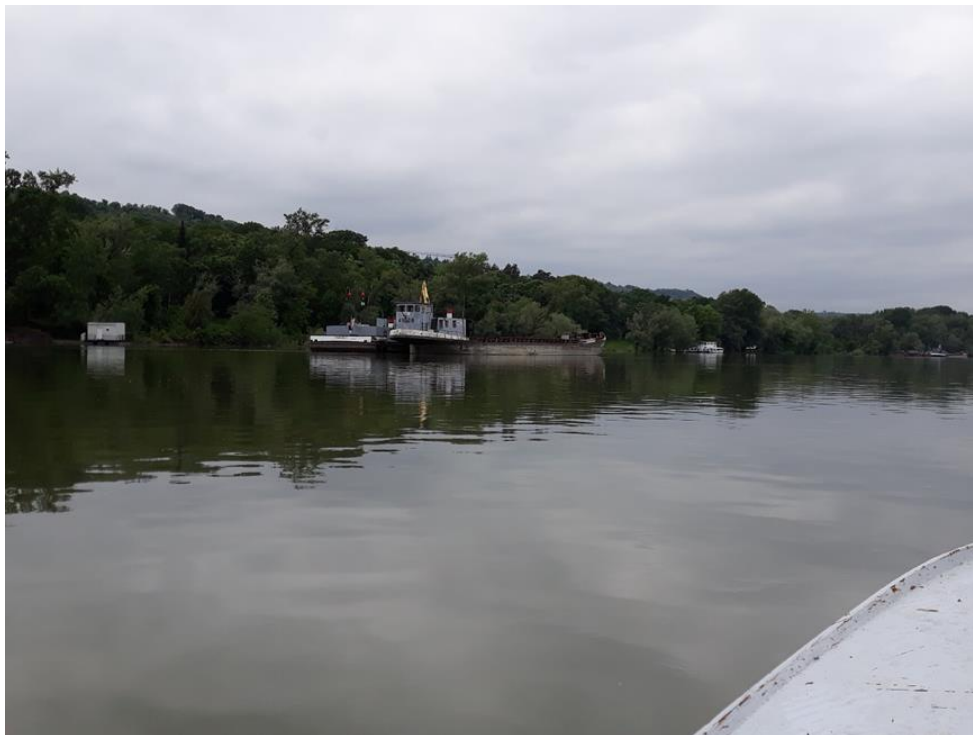
Floating barge with construction material is used as a temporary storage for solid material like steel armature (reinforcement bar) and new rolls of geotextile are into the foil Floating office.
