INTERMEDIATE ENVIRONMENTAL MONITORING REPORT DURING WORKS

FUTOG – SUMMARY OF RESULTS

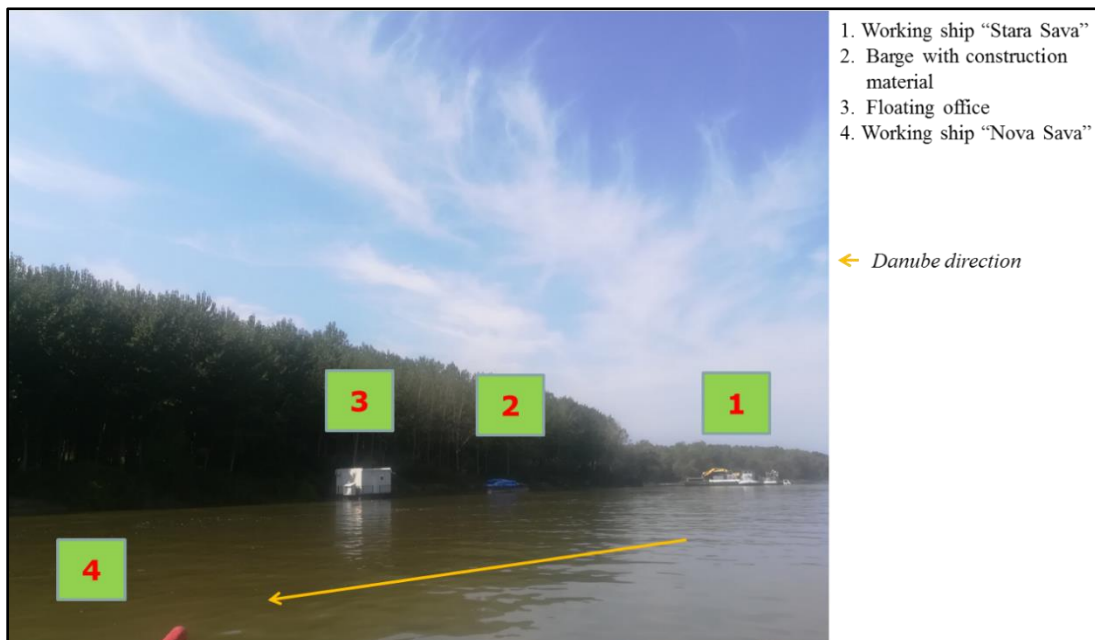
Figure 1 Display of construction sites and auxiliary objects within the Futog critical sector (Futog 2 subsector)

Construction of detached groyne is performed from the ship “Stara Sava” at location that is positioned upstream (position 1 at Figure 1), while the construction of chevron is performed from the ship “Nova Sava” at the downstream position (position 4 at Figure X). A distance between these construction sites is about 400 m.

Floating barge with construction material (position 2 at Figure 1) is used as a temporary storage for solid material like steel armature (reinforcement bar) and new rolls of geotextile are into the foil Floating office (position 3 at Figure 1).
