INTERMEDIATE ENVIRONMENTAL MONITORING REPORT DURING WORKS n° 2

FUTOG – SUMMARY OF RESULTS

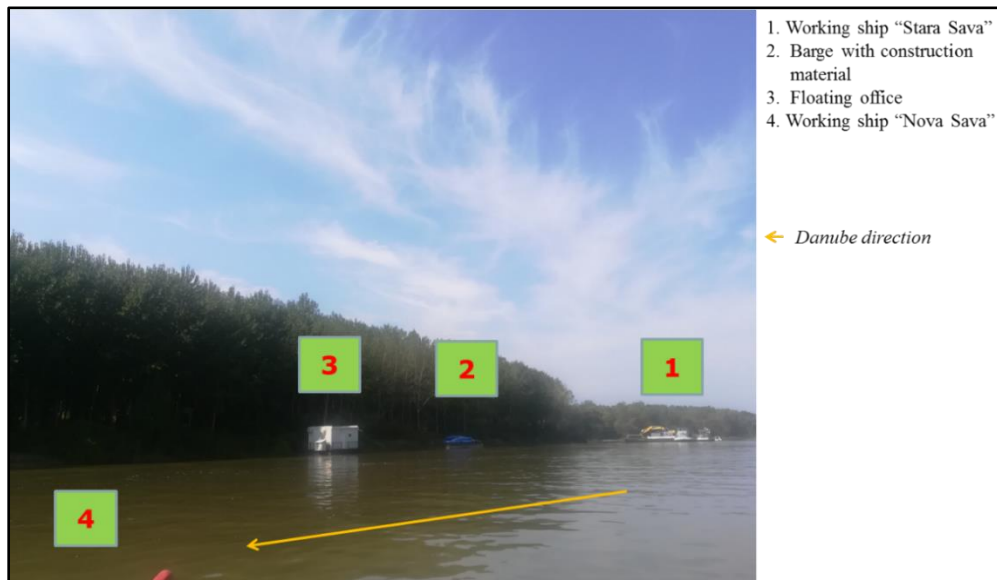
Figure 1 Display of construction sites and auxiliary objects within the Futog critical sector (Futog 2 subsector)

Construction of detached groyne is performed from the ship “Stara Sava” at location that is positioned upstream (position 1 at Figure 1), while the construction of chevron is performed from the ship “Nova Sava” at the downstream position (position 4 at Figure X). A distance between these construction sites is about 400 m.

Floating barge with construction material (position 2 at Figure 1) is used as a temporary storage for solid material like steel armature (reinforcement bar) and new rolls of geotextile are into the foil Floating office (position 3 at Figure 1).

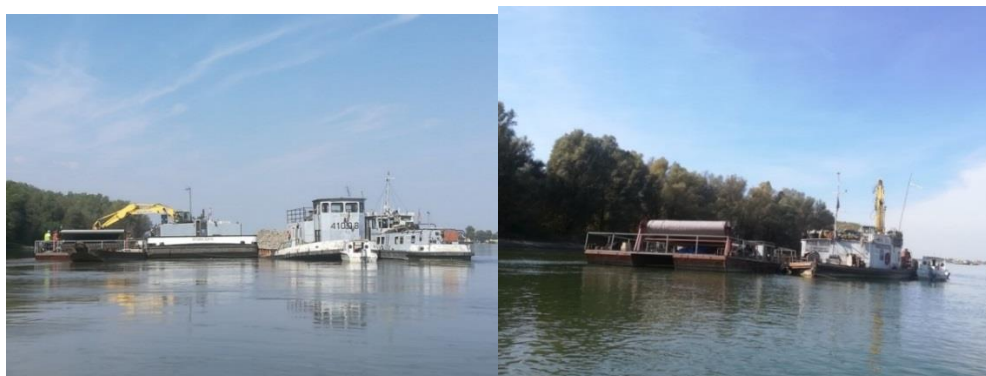
Figure 2 Display of construction sites and working ships “Stara Sava” (left) and “Nova Sava” (right) – upstream view

Futog is the only critical sector where works execution is in progress in this moment. Construction works are being performed on two locations within the subsector Futog 2, on the right side of the Danube River – construction of detached groyne and chevron, while dredging works on subsector Futog 1 are not started in this moment.
