INTERMEDIATE ENVIRONMENTAL MONITORING REPORT DURING WORKS n° 4

FUTOG – SUMMARY OF RESULTS

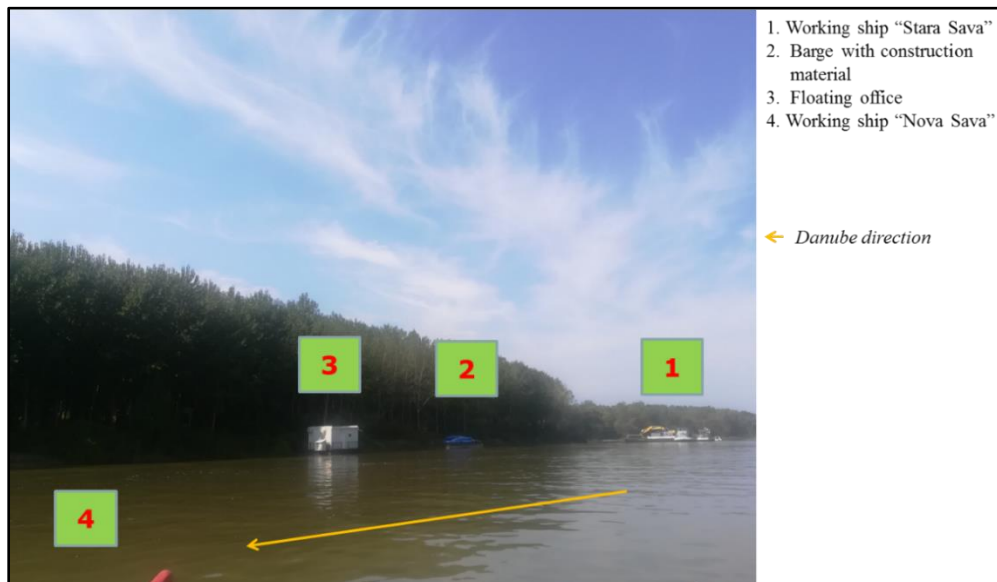
The construction Works have been finalized up to the profiling of the body” at location that is positioned upstream (position 1 at Figure 1), while the construction of chevron is performed from the ship “Nova Sava” at the downstream position (position 4 at Figure 1). A distance between these construction sites is about 400 m.

Floating barge with construction material (position 2 at Figure 1) is used as a temporary storage for solid material like steel armature (reinforcement bar) and new rolls of geotextile are into the foil Floating office (position 3 at Figure 1)

Figure 1 Display of construction sites and auxiliary objects within the Futog critical sector (Futog 2 subsector)

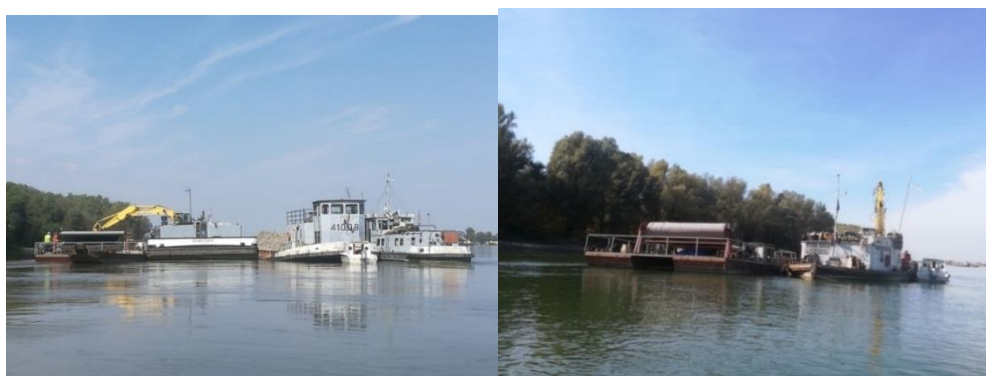
Figure 2 Display of construction sites and working ships "Stara Sava" (left) and "Nova Sava" (right) – upstream view
