# **Supervision and Environmental Monitoring of River Training and Dredging Works on Critical Sectors on the Danube River**

STAKEHOLDERS' FORUM – 23<sup>th</sup> March 2018

Republic of Serbia  
Ministry of Construction,  
Transport and Infrastructure

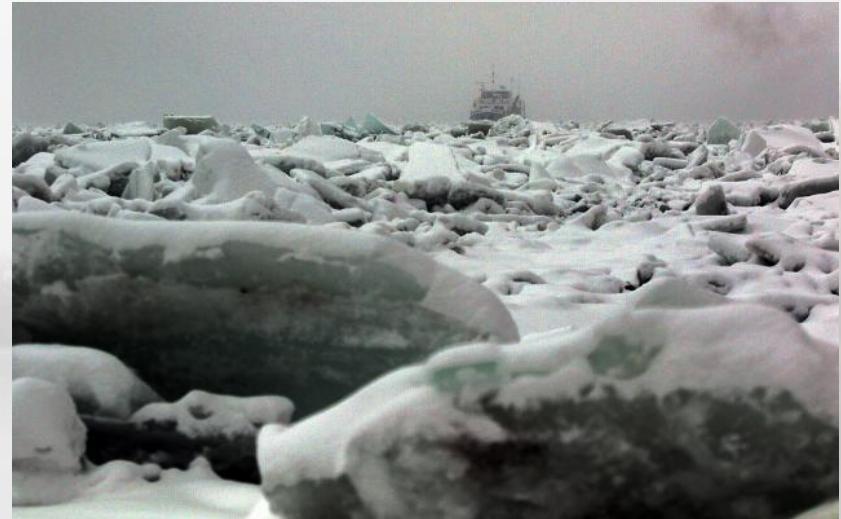
**2006, 2008, 2012 and 2017: years with fairway covered with ice by more than 60%**

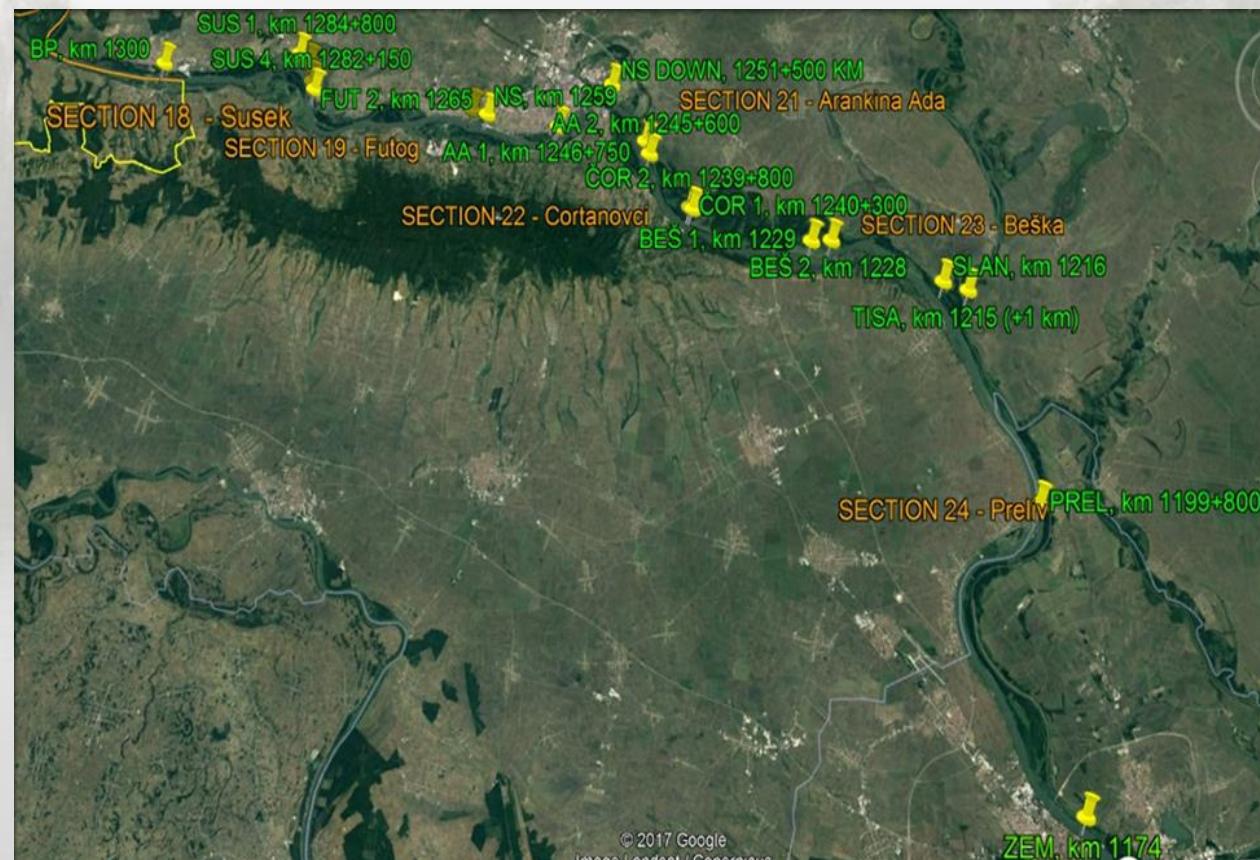
*Position of the profiles where baseline sampling was done (November 2017)*

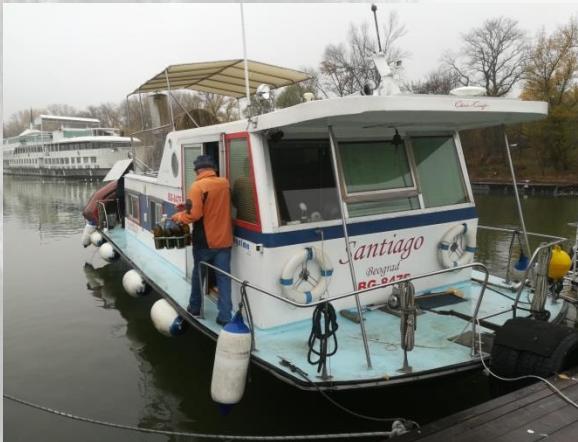
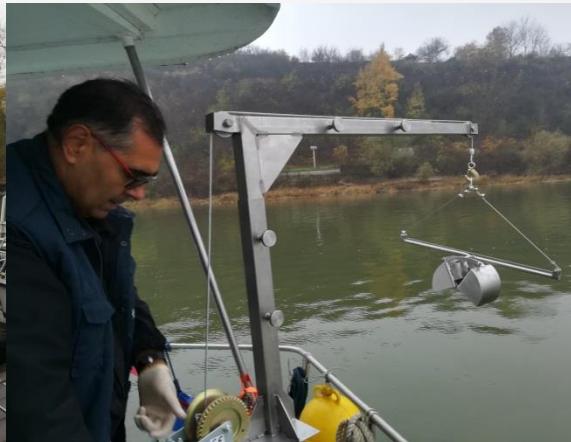
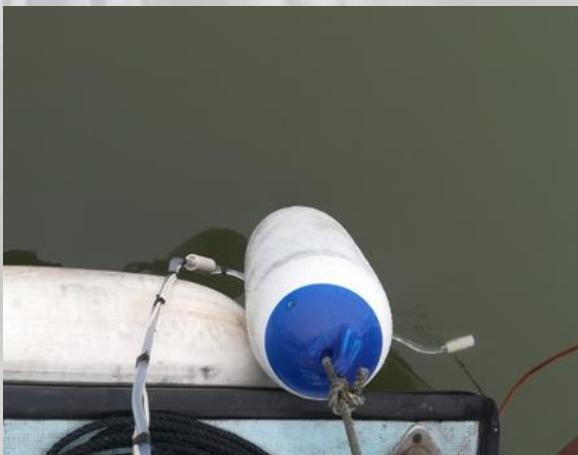
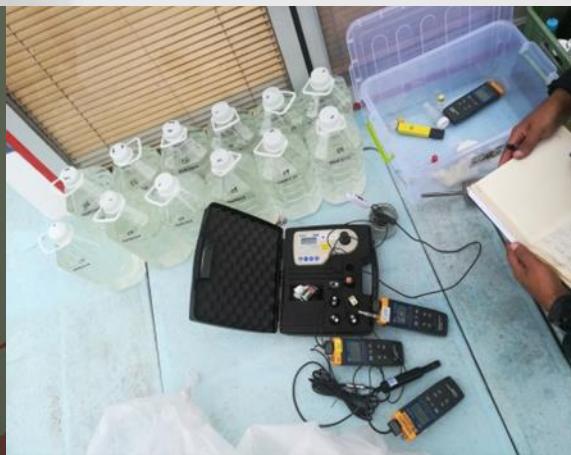
- temperature,
- turbidity,
- pH value,
- conductivity,
- dissolved oxygen

*Ship and some equipment used for water and sediment sampling (November 2017)*

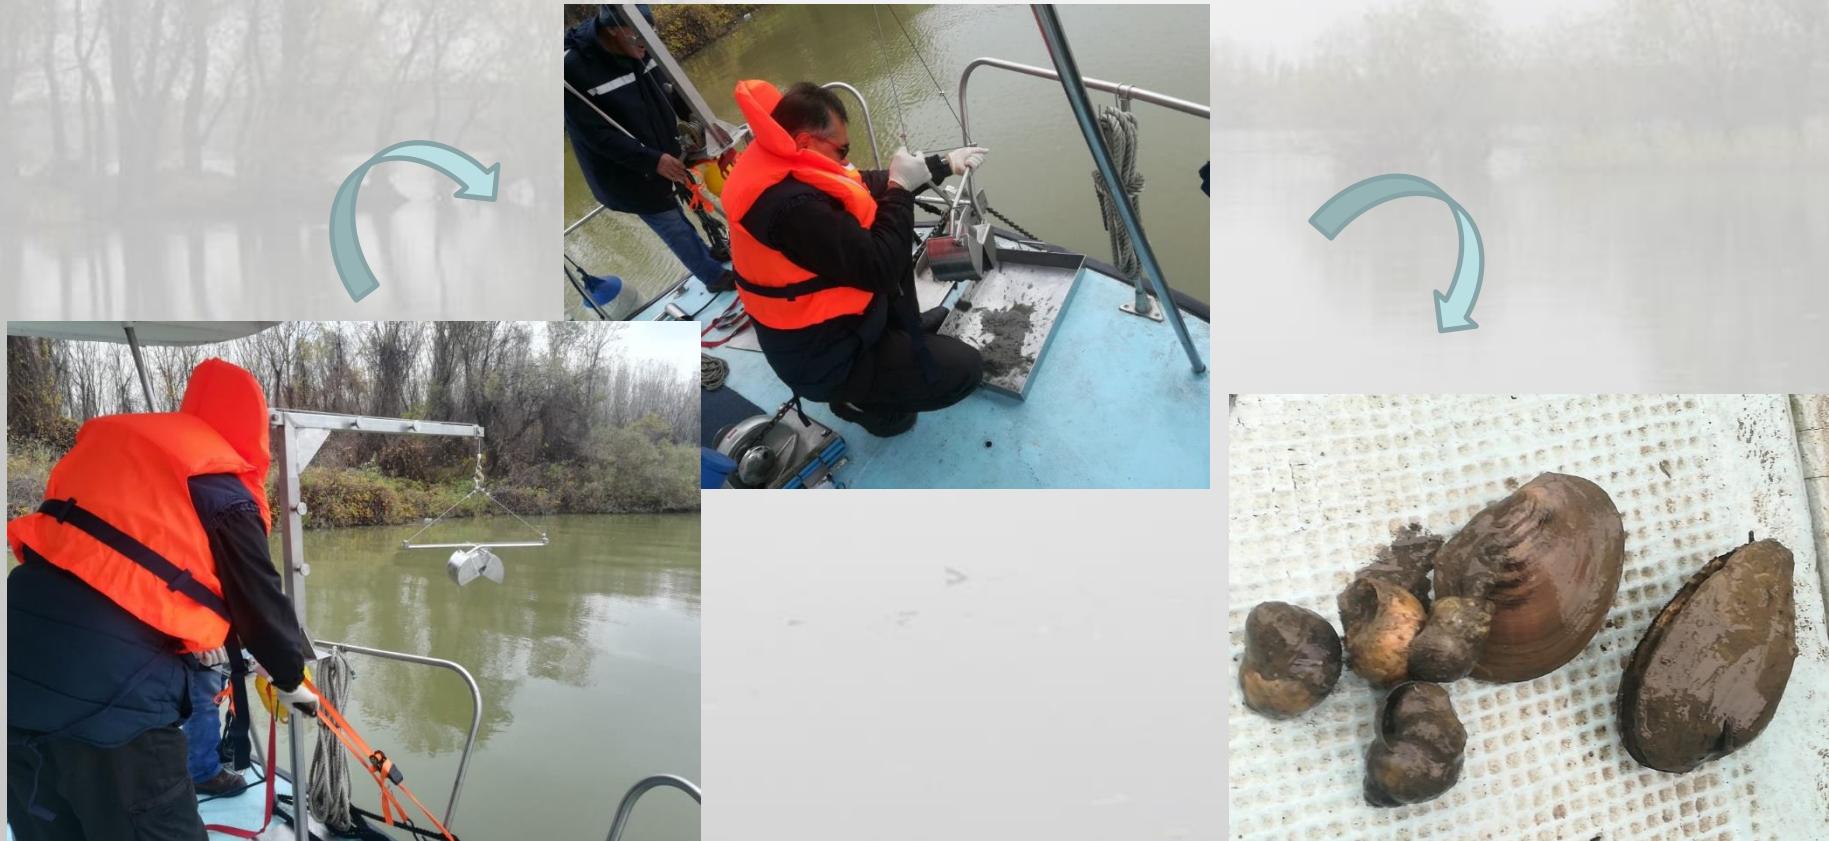
Samples were taken by using stainless steel “hand bucket” (on the motor boat) up to 7 m depths from water sediment. After getting out of the water, samples were partially dried in order to reduce the mass of the sediment, after which mussel individuals were separated and identified.
