# Supervision and Environmental Monitoring of River Training and Dredging Works on Critical Sectors on the Danube River

THE FIFTH STAKEHOLDER'S FORUM MEETING – 05th April 2019

Futog km 1267.400 to km 1261.600

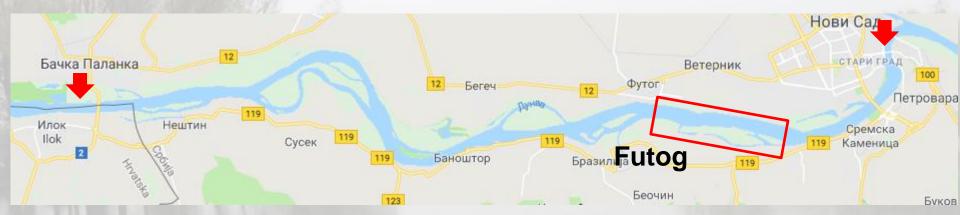
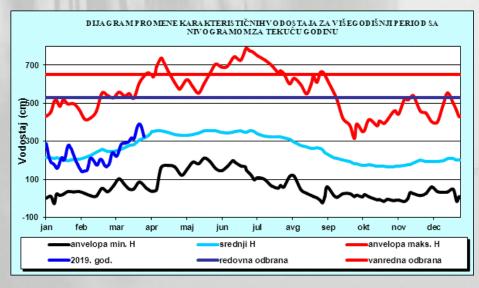
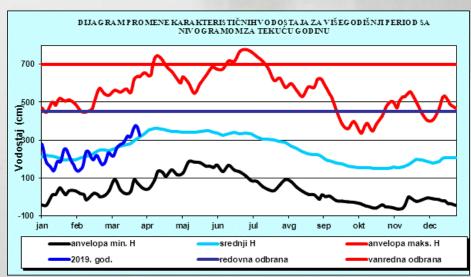
# acciona Water level gauging stations

Bačka Palanka: "0" 73.97 maAs Km 1298.560

**Novi Sad:** "0" 71.73 maAs Km 1254.980

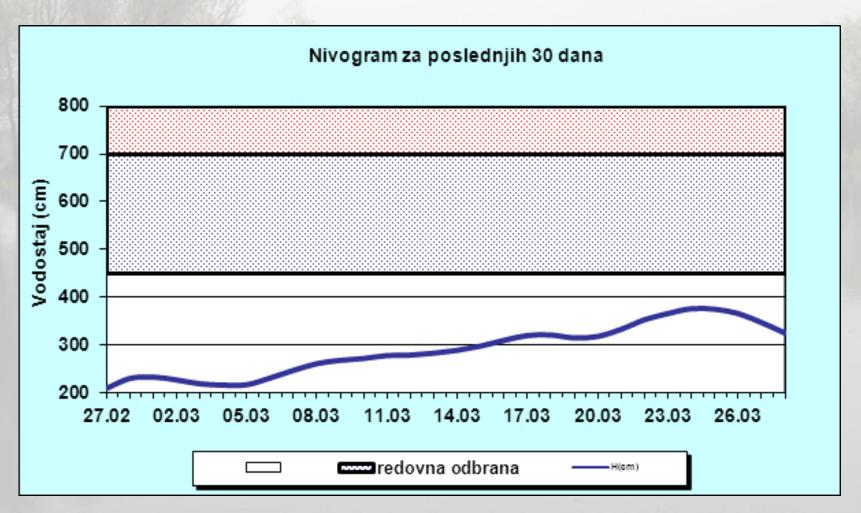
# Gauging station Novi Sad – last 30 days

Novi Sad: "0" 71.73 maAs Km 1254.980

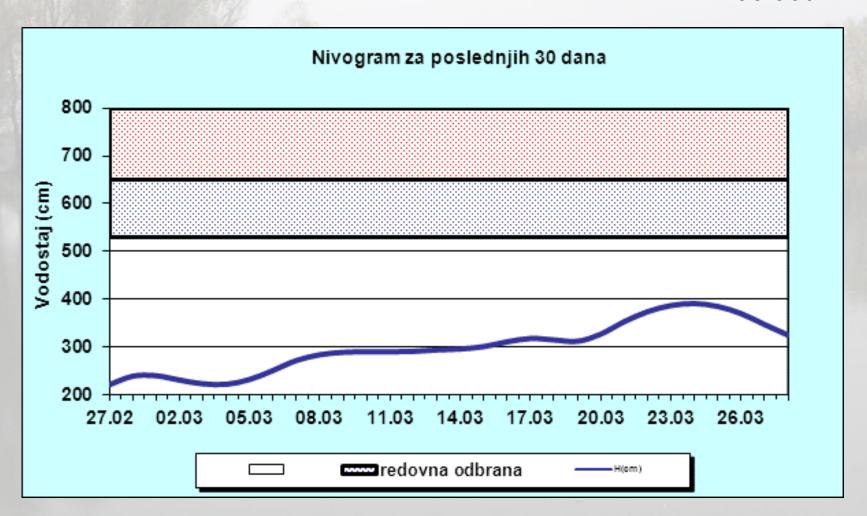
# Gauging station Backa Palanka – last 30 days

Backa Palanka: "0" 73.97 maAs Km 1298.560
