INTERMEDIATE ENVIRONMENTAL MONITORING REPORT AFTER WORKS

ARANKINA ADA – SUMMARY OF RESULTS

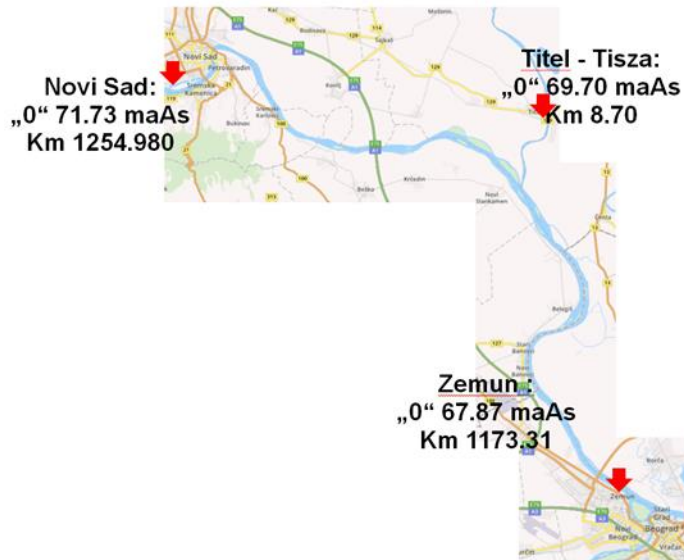
The stretch Arankina ada has been located between the gauging stations Novi Sad, Titel and Zemun, nearer to Novi Sad. Titel is a referent gauging station for the Tisza river, and it is located in the vicinity of the Tisa Danube confluence.

Arankina ada stretch is one of the typical Danube stretches with several interconnected isles arranged in a row along with the river current. The most downstream river island name (Arankina Ada) named the whole stretch. The stretch morphological development begins after several sharp bends in Novi Sad's zone when the river current slows down and creates the circumstances for bedload deposition.

The consequent river islands are located in the middle of the river flow closer to the left riverbank, except the last one (Arankina Ada), which splits the river current into two equivalent river branches. Even water depths in the branches are similar, around 7m below LNL. Accordingly, the capacities in terms of the bedload and water volume discharges are similar too.

The survey made in July 2021 shows that the navigation channel formed by the dredging works permanently maintain width and depth for the navigational channel. Three months after the work completion, the width available for navigation between km1246+050 and km 1245+850 is severe narrowed. The navigational channel contraction on the appointed section is about 20m. The critical contour line is 69maAs (cyan), separating 3m water depth related to the Low Navigational Levels (LNL).
