## INTERMEDIATE ENVIRONMENTAL MONITORING REPORT DURING WORKS n° 3

### FUTOG – SUMMARY OF RESULTS

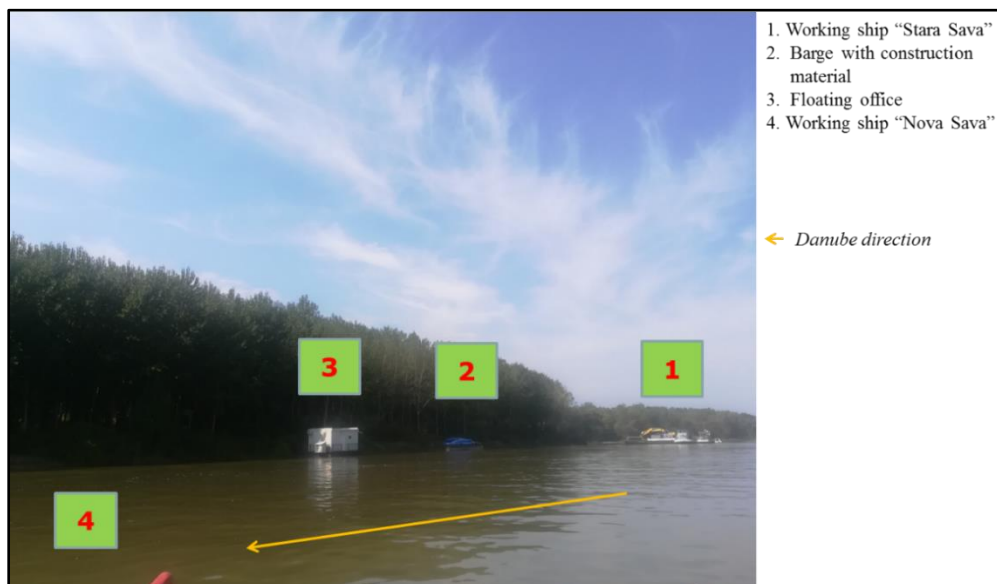
Figure 1 Display of construction sites and auxiliary objects within the Futog critical sector (Futog 2 subsector)

The construction Works have been finalized up to the profiling of the body” at location that is positioned upstream (position 1 at Figure 1), while the construction of chevron is performed from the ship “Nova Sava” at the downstream position (position 4 at Figure 1). A distance between these construction sites is about 400 m.

Floating barge with construction material (position 2 at Figure 1) is used as a temporary storage for solid material like steel armature (reinforcement bar) and new rolls of geotextile are into the foil Floating office (position 3 at Figure 1)

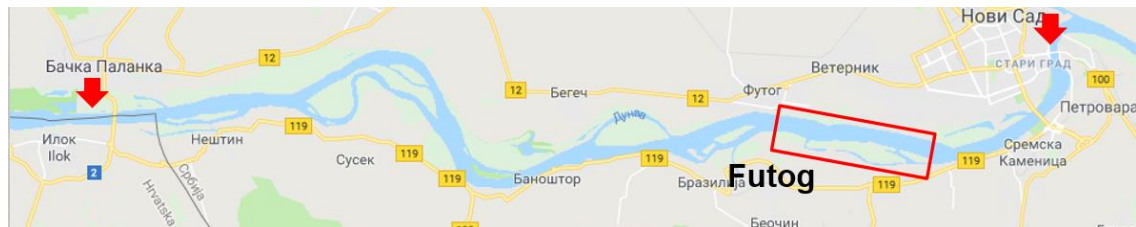
River stretch Futog is located upstream from Novi Sad, second most populated town in Serbia. Its position is between gauging stations Novi Sad and Backa Palanka.
