INTERMEDIATE ENVIRONMENTAL MONITORING REPORT DURING WORKS n° 2

ČORTANOVCI – SUMMARY OF RESULTS

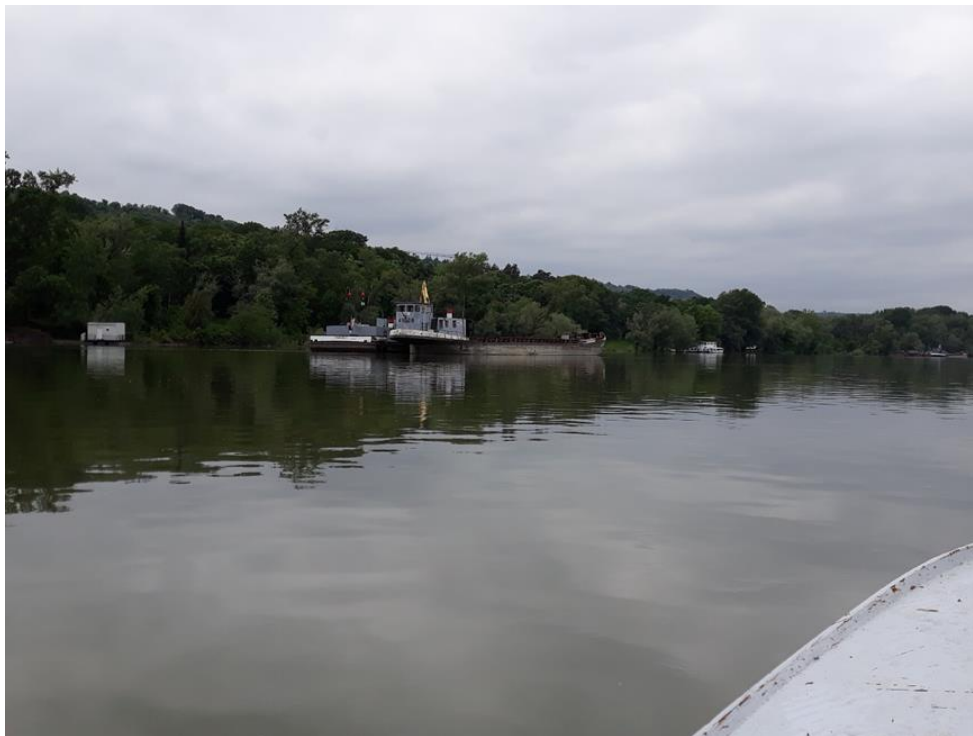
Floating barge with construction material is used as a temporary storage for solid material like steel armature (reinforcement bar) and new rolls of geotextile are into the foil Floating office.

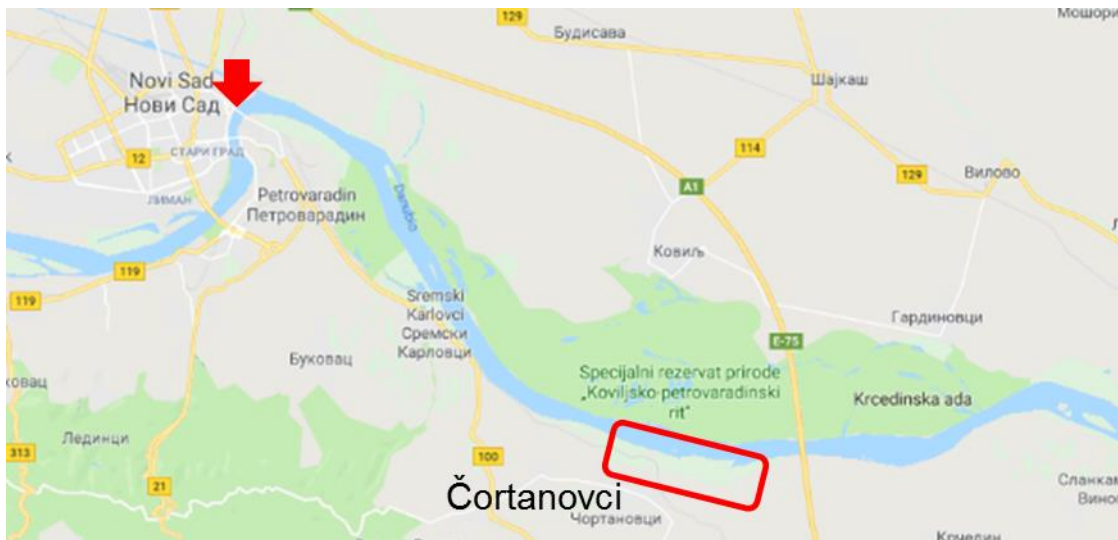
River stretch Čortanovci is located downstream from gauging station Novi Sad.
