INTERMEDIATE ENVIRONMENTAL MONITORING REPORT DURING WORKS no.2

PRELIV – SUMMARY OF RESULTS

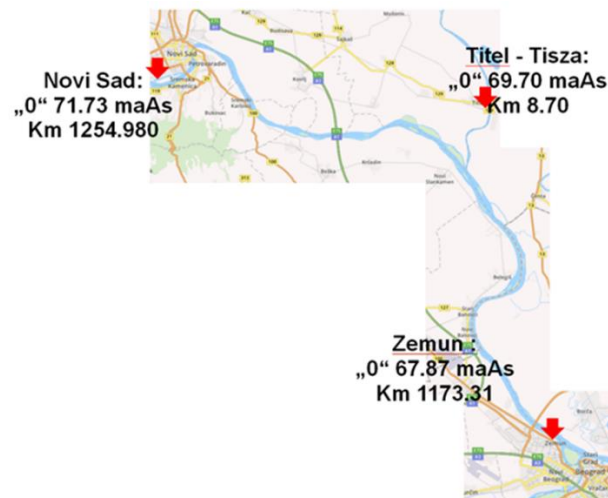
Gauging station Zemun is referent station for stretch Preliv.

Stretch has right river band shape with radius which gradually becomes smaller. The most upstream part of the stretch is narrow (about 500m) with talweg depth about 6.5m. Cross-section is U shaped and provides optimal transportation capacity in terms of discharges and bed load transportation.
