INTERMEDIATE ENVIRONMENTAL MONITORING REPORT DURING WORKS

ARANKINA ADA – SUMMARY OF RESULTS

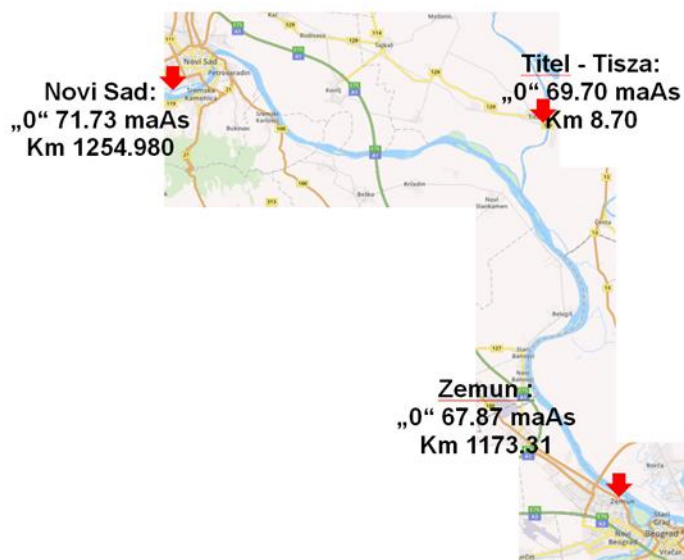
The stretch Arankina ada has been located between the gauging stations Novi Sad, Titel and Zemun, nearer to Novi Sad. Titel is a referent gauging station for the Tisza river, and it is located in the vicinity of the Tisa Danube confluence.

Arankina ada stretch is one of the typical Danube stretches with several interconnected isles arranged in a row along with the river current. The most downstream river island name (Arankina Ada) named the whole stretch. The stretch morphological development begins after several sharp bends in Novi Sad's zone when the river current slows down and creates the circumstances for bedload deposition.
