Morphological modelling results Futog

Preparation of Documentation for River Training and Dredging Works on Selected Locations along the Danube River. A project funded by the European Union

19. Sector – Futog (km 1,267.4 – 1,261.6)

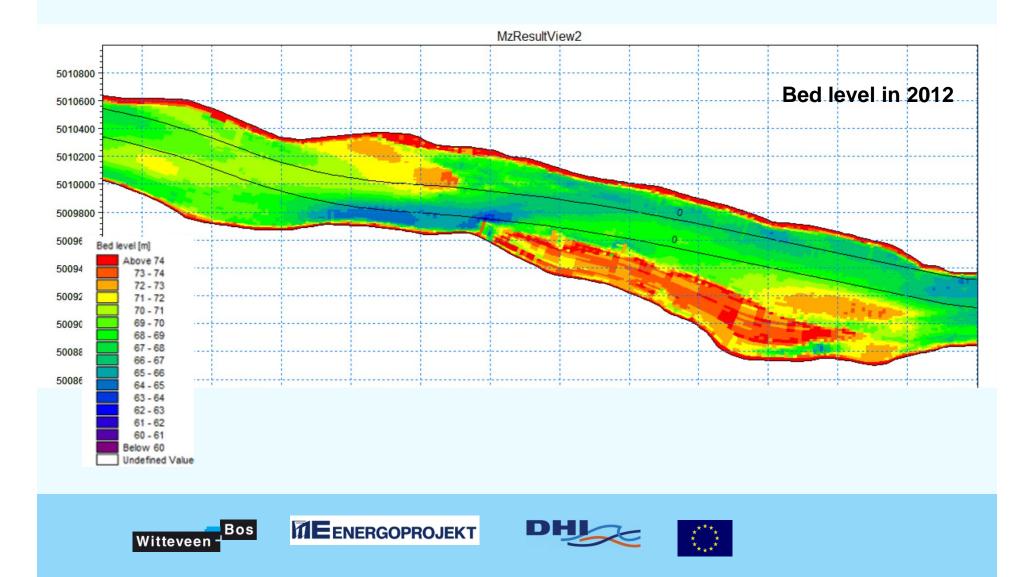
19. Futog – existing situation

Where is the depth less than 2.5 at DLNL (2012)?

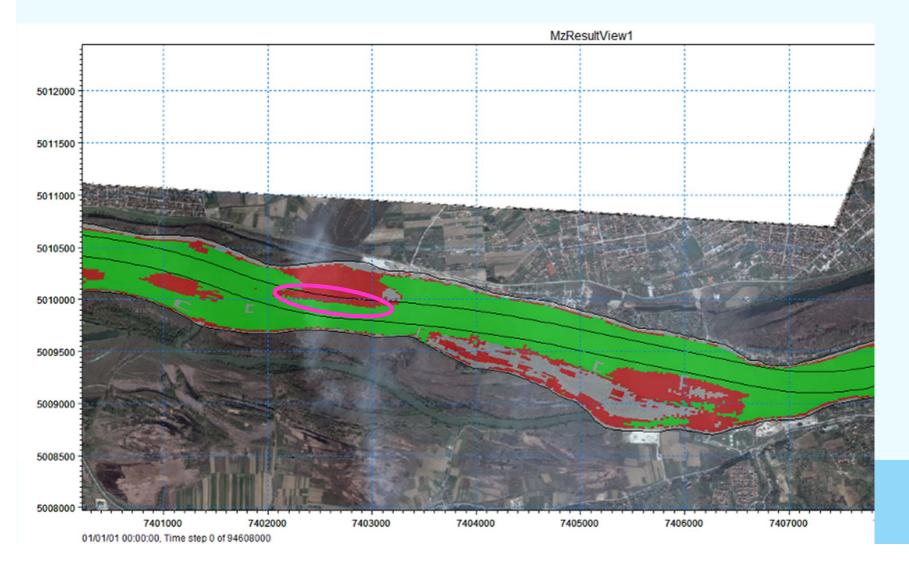
19. Futog - simulation

Conceptual design: Simulated bed level changes after 3

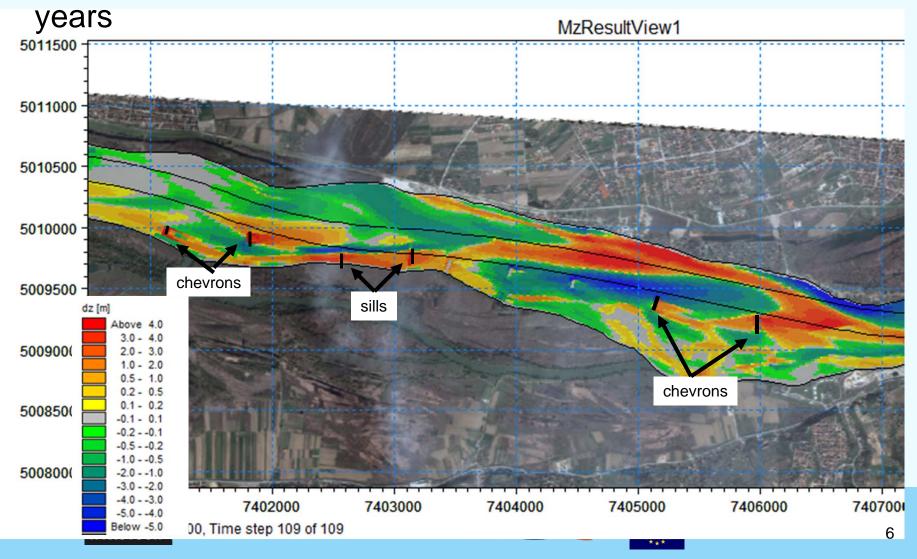
19. Futog - simulation

Simulated bed level changes after 3 years

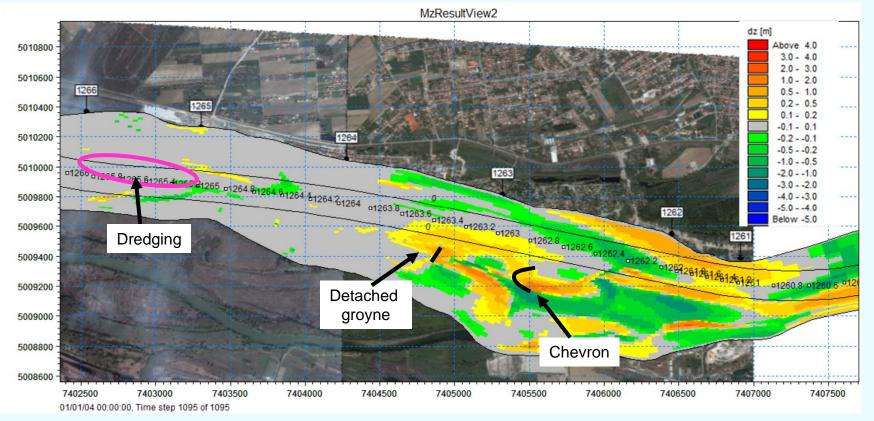
- Upstream: dredging;
- Downstream: detached groyne (DLNL + 1m) and a chevron (DLNL)

- Conceptual design (Phase 2) induces to much adverse morphological impacts.
- Amount of river training works has been reduced to:
 - Dredging upstream;
 - Downstream: detached groyne and chevron.
- Dredging volume and backfilling time to be assessed

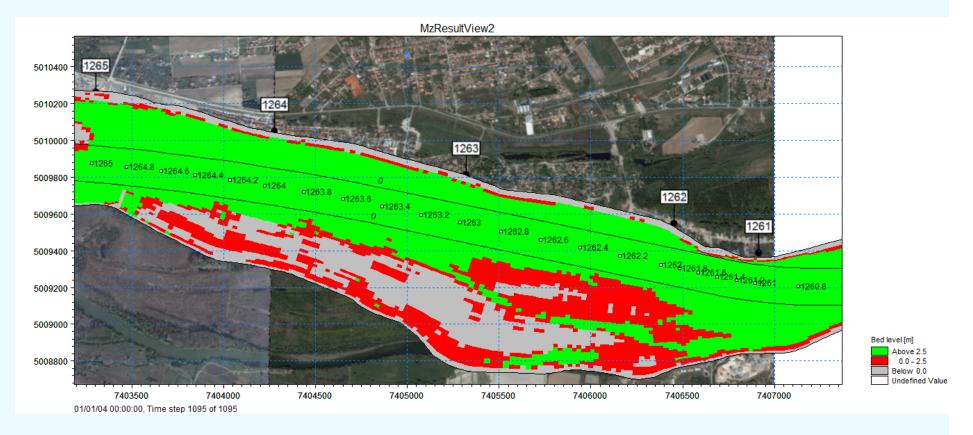
19. Futog - simulation

• Sufficient depth after simulation of 3 years?
