INTERMEDIATE ENVIRONMENTAL MONITORING REPORT DURING WORKS n° 4

FUTOG – SUMMARY OF RESULTS

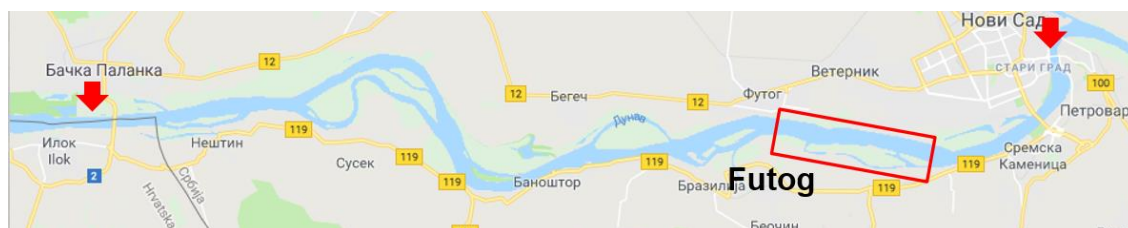
River stretch Futog is located upstream from Novi Sad, second most populated town in Serbia. Its position is between gauging stations Novi Sad and Backa Palanka.
