## INTERMEDIATE ENVIRONMENTAL MONITORING REPORT AFTER WORKS n° 2

### ČORTANOVCI – SUMMARY OF RESULTS

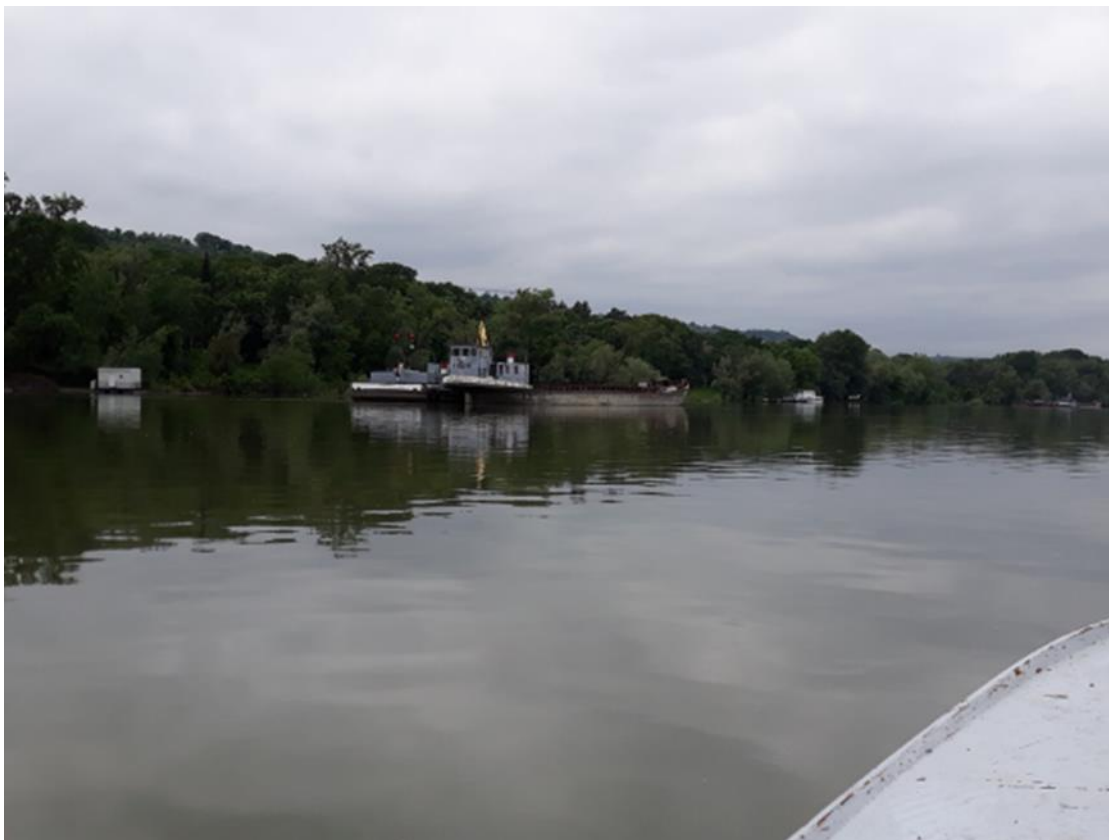
Figure 1 Čortanovci critical sector

Construction works have been performed on two locations Sill 22.2 and sill 22.1.

Construction works were started at the downstream location (sill 22-2), and just after approximately three weeks (May 15<sup>th</sup> they were started at the upstream location, sill 22.1).

Downstream of Vojvodina capital – Novi Sad between km1241+600 and km1235 has been situated stretch Čortanovci. It is characterized by a typical hourglass shape, with approximately 350m width at the narrowest section. River bed are tapering from the width of 600 m to 350 m in contraction and spreading on 840 m downstream. Such morphological characteristics are favorable for bed load deposition downstream of contraction where water current slowing down and provides conditions for sedimentation. Water flow is divided into two currents, where one of the branches is dominant and attracts more water flow.
